**Flood Control Project Maintenance
Levee Inspections**

Fall 2016 Levee Maintenance Deficiency Summary Report

Sacramento River Basin

Sutter Maintenance Yard Tisdale Bypass

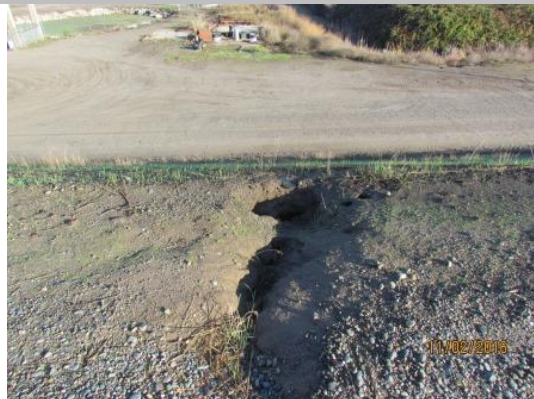
Photo 1 of 2 : FA_2016_ST0009_286_12_20161107_00010.jpg

LM Start	2.16	Rating **	U	Issue No.	12
LM End	2.16	Issue Type +	Ma	Location *	LS
Category	Earthen Levee			GPS Latitude/Longitude	
				Start	End
Item	Animal Control			39.028137 °	39.028137 °
				-121.782020 °	-121.782020 °
DWR ID	DWR_ST0009_01_f_2016_12				
Comment Code					
A3 : No rodents visible, but rodent burrows visible; need to backfill and compact or grout burrows.					
Inspector Comment

View of a rodent hole along the levee crown.

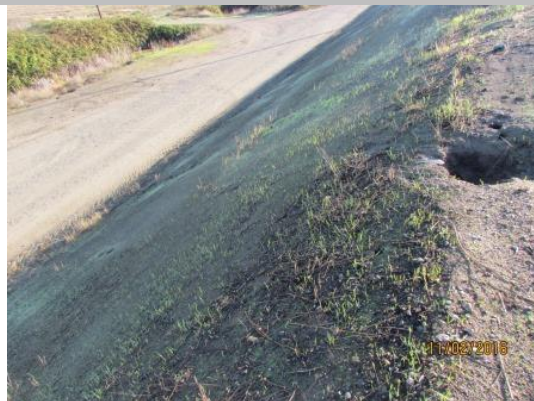
Photo 2 of 2 : FA_2016_ST0009_286_12_20161107_00012.jpg

Another view of the rodent holes along the crown and landside slope.

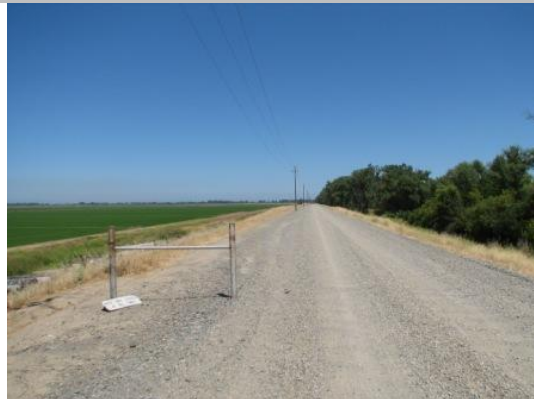
Photo 1 of 1 : FA_2016_ST0009_286_3_20160823_00001.jpg

LM Start	2.19	Rating **	M	Issue No.	3
LM End	4.11	Issue Type +	En	Location *	LS
Category	Earthen Levee			GPS Latitude/Longitude	
				Start	End
Item	Encroachments			39.028173 °	39.028012 °
				-121.781475 °	-121.745665 °
DWR ID	DWR_ST0009_01_s_2012_3				
Comment Code					
PO : Pole					
Inspector Comment

View of the PG&E poles along the landside crown of the levee.

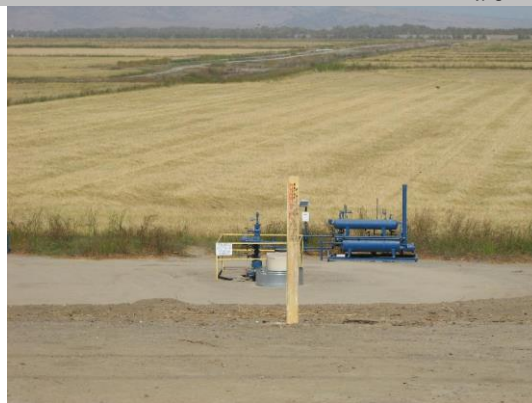
Photo 1 of 1 : UCIP_FA_2016_50256_64220.jpg

Comment Code					
Inspector Comment					
FS_ID:50256 DS_ID:16590 EP_NO: 14740 Repair Type: Non-Urgent Crossing Status: Indicator Found UCIP Comments: 10/11/2016 Carsonite marker on WS shoulder is still missing.(DWR Sutter Yard - afreitag)4/18/2016 Carsonite marker on WS shoulder is missing.5/7/2015 Marker on WS shoulder missing.11/13/2014 Same as last inspection.5/12/2014 Same as last inspection.10/30/2013 Same as last inspection.5/20/2013 Carsonite marker on WS shoulder missing and should be replaced. FIELD_STRUCT_DESC: 4-inch steel gas pipe through the levee and under channel, 2.5 feet below the crown. Carsonite signs on both landside (LS) and waterside (WS) shoulder. Gas Wells 200 feet off of LS toe. (Permit No. 14740, 1988 - Nahama and Weagant Energy Co.) [Additional Reference(s): DWR Levee Log, 1993] FS Date: 10/11/2016 1:26:31 PM

Carsonite sign on LS shoulder with view of gas well in background.

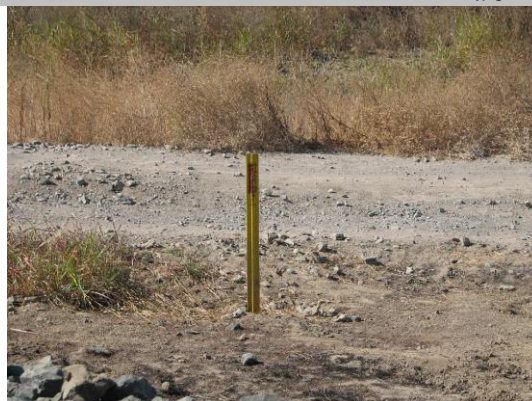
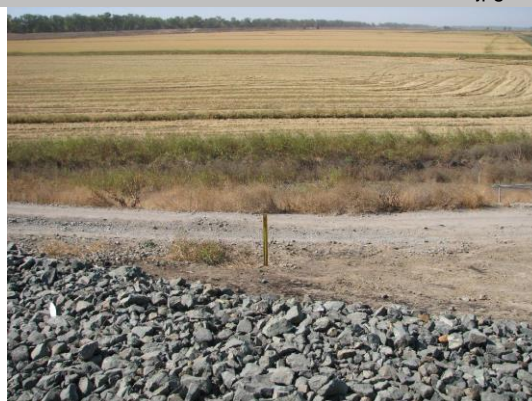
FS_ID:50257
DS_ID:16855
EP_NO: 14455
Repair Type: Non-Urgent
Crossing Status: Indicator Found
UCIP Comments: 10/11/2016 LS carsonite marker is still broken.(DWR Sutter Yard - afreitag)4/18/2016 Carsonite marker on LS slope is broke off.5/7/2015 Crossing is in good condition. No noticeable issues to report.11/13/2014 Same as last inspection.5/12/2014 Same as last inspection.10/30/2013 Same as last inspection.5/20/2013 Same as last inspection.
FIELD_STRUCT_DESC: 1 of 2: 4.5-inch steel natural gas pipeline through the levee, 2 feet below the crown. Line goes across the Sutter Bypass and through both levees. Carsonite sign on the landside (LS) slope. Drawings are available. (Permit No. 14455, 1986 - Depco Inc.)
[Additional Reference(s): DWR Levee Log, 1993]
FS Date: 10/11/2016 1:29:05 PM

Carsonite sign on LS slope.

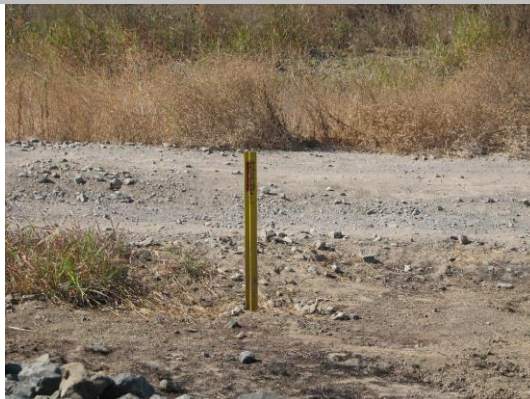
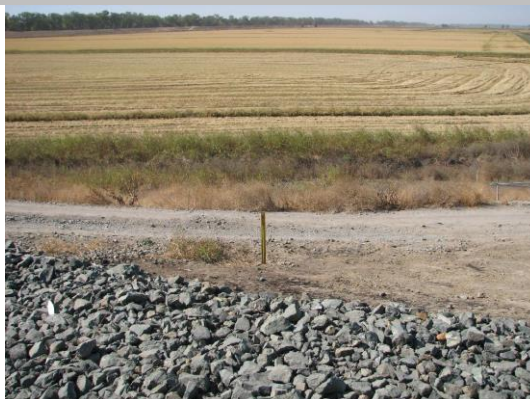
FS_ID:50258
DS_ID:16589
EP_NO: 14455
Repair Type: Non-Urgent
Crossing Status: Indicator Found
UCIP Comments: 10/11/2016 Carsonite marker on the LS is still broken.(DWR Sutter Yard - afreitag)4/18/2016 Carsonite marker on LS slope is broken off.5/7/2015 Crossing is in good condition. No noticeable issues to report.11/13/2014 Same as last inspection.5/12/2014 Same as last inspection.10/30/2013 Same as last inspection.5/20/2013 Same as last inspection.
FIELD_STRUCT_DESC: 2 of 2: 4.5-inch steel natural gas pipeline through the levee, 2 feet below the crown. Line goes across the Sutter Bypass and through both levees. Carsonite sign located on the landside (LS) slope. (Permit No. 14455, 1986 - Depco Inc.) [Additional Reference(s): DWR Levee Log, 1993]
FS Date: 10/11/2016 1:30:34 PM

Carsonite sign on LS slope.

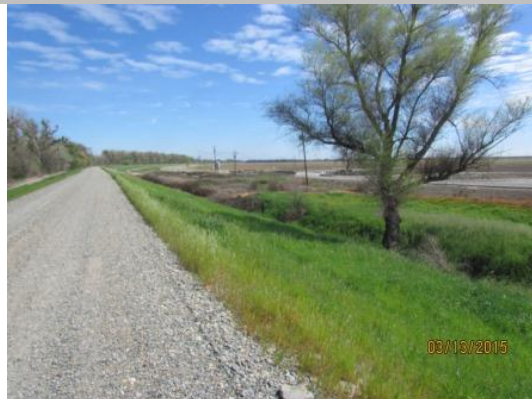
Photo 1 of 1 : FA_2016_ST0009_287_1_20160823_00001.jpg

LM Start	0.11	Rating **	M	Issue No.	1
LM End	0.26	Issue Type +	En	Location *	LS
Category	Earthen Levee			GPS Latitude/Longitude	
				Start	End
Item	Encroachments			39.023760 °	39.024559 °
				-121.818875 °	-121.816344 °
DWR ID	DWR_ST0009_02_s _ 2012_1				
Comment Code					
DT : Ditch					
Inspector Comment					
Monitor the ditch for erosion.

View of the agricultural ditch along the landside toe.

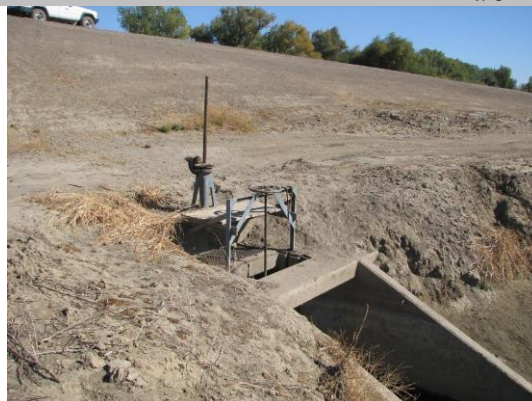
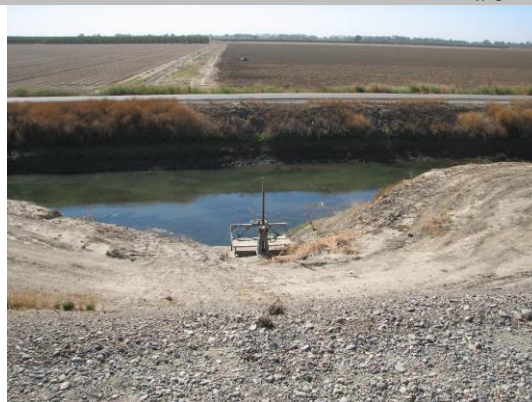
Comment Code					
Inspector Comment					
FS_ID:50250 DS_ID:16594 EP_NO: 267 Repair Type: Non-Urgent Crossing Status: Found UCIP Comments: 10/11/2016 Erosion still present behind the WS vault.(DWR Sutter Yard - afreitag)4/18/2016 Erosion happening around the WS concrete vault.5/7/2015 Burrowing near WS toe stil present.11/13/2014 Same as last inspection.5/12/2014 Same as last inspection.10/30/2013 Same as last inspection.5/20/2013 Same as last inspection.10/17/2012 Burrowing along downstream side of concrete vault on WS Toe. May need to be grouted. FIELD_STRUCT_DESC: 54-inch reinforced concrete irrigation pipe through the levee, 29.5 feet below the crown. Slide gates on both waterside (WS) and landside (LS) ends. WS end gate in 5-foot by 6-foot concrete box. LS end gate in concrete "U" headwall. Siphon pipe under and across bypass, steel concrete encased. (Permit No. 267 & 290 - Sutter Basin Water Co.) [Additional Reference(s): DWR Levee Log, 1993. USACE Sacramento O&M Manual 129, August 1955 (Station 61+25)]. FS Date: 10/11/2016 1:03:24 PM

Slide gate at concrete outlet on LS toe.

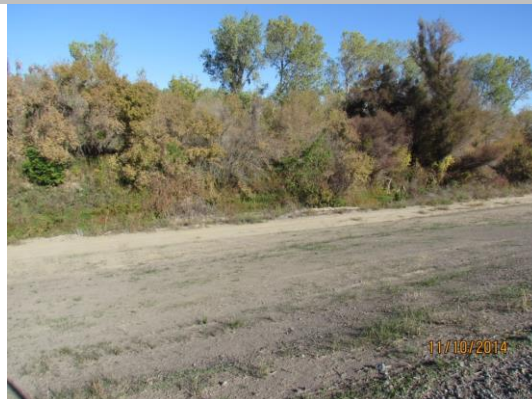
Photo 1 of 1 : FA_2016_ST0009_287_4_20160823_00004.jpg

LM Start	1.29	Rating **	M	Issue No.	4
LM End	1.29	Issue Type +	Ma	Location *	WS
Category	Earthen Levee			GPS Latitude/Longitude	
				Start	End
Item	Erosion / Bank Caving			39.025478 °	39.025478 °
				-121.797232 °	-121.797232 °
DWR ID	DWR_ST0009_02_s _ 2013_4				
Comment Code					
E2 : Schedule repair of erosion site prior to the next inspection.					
Inspector Comment					
Sutter Yard needs to monitor the erosion.

View of the erosion along the waterside berm.

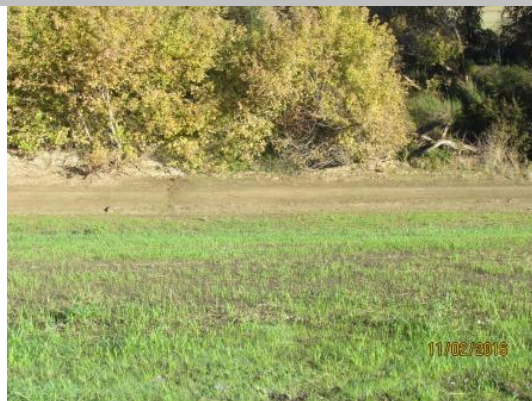
Photo 1 of 1 : FA_2016_ST0009_287_5_20161107_00021.jpg

LM Start	1.48	Rating **	M	Issue No.	5
LM End	1.50	Issue Type +	Ma	Location *	WS
Category	Earthen Levee			GPS Latitude/Longitude	
				Start	End
Item	Erosion / Bank Caving			39.025460 °	39.025446 °
				-121.793815 °	-121.793347 °
DWR ID	DWR_ST0009_02_s _ 2013_5				
Comment Code					
E2 : Schedule repair of erosion site prior to the next inspection.					
Inspector Comment					
Sutter Yard needs to monitor the erosion.

View of the erosion along the waterside berm.

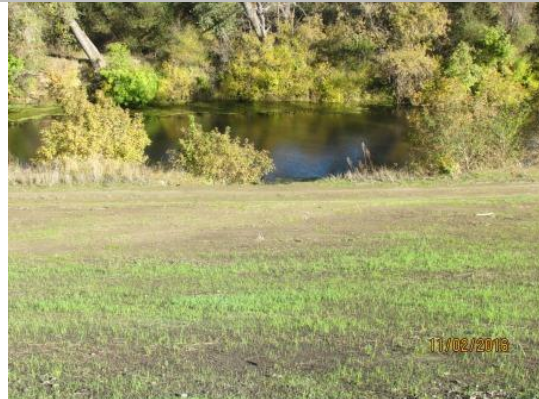
Photo 1 of 1 : FA_2016_ST0009_287_2_20161107_00020.jpg

LM Start	3.93	Rating **	M	Issue No.	2
LM End	3.93	Issue Type +	Ma	Location *	WS
Category	Earthen Levee			GPS Latitude/Longitude	
				Start	End
Item	Erosion / Bank Caving			39.025060 °	39.025060 °
				-121.748178 °	-121.748178 °
DWR ID	DWR_ST0009_02_f_2016_2				
Comment Code					
E1 : Note and monitor erosion site.					
Inspector Comment

View of the erosion along the waterside berm.

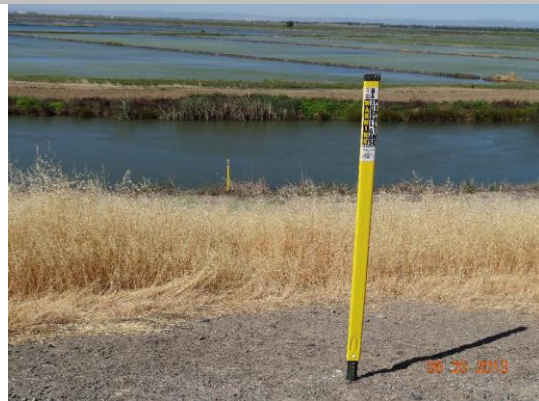
Photo 1 of 2 : UCIP_FA_2016_50252_64681.jpg

Comment Code					
Inspector Comment					
FS_ID:50252 DS_ID:23099 EP_NO: N/A Repair Type: Non-Urgent Crossing Status: Found UCIP Comments: 10/11/2016 Crossing appears to be in good condition but there is no permit on file. Photos of the markers were uploaded on 5/20/2013.(DWR Sutter Yard - afreitag)5/3/2016 Need photos of markers on both WS and LS. 4/18/2016 Crossing appears to be in good condition. No noticeable issues to report.5/7/2015 Crossing is in good condition. No noticeable issues to report.11/13/2014 Same as last inspection.5/12/2014 Same as last inspection.10/30/2013 Same as last inspection.10/17/2012 Need to identify permit for crossing. FIELD_STRUCT_DESC: Unknown size natural gas pipeline through the levee at an unknown depth below the crown. Markers visible on the landside (LS) shoulder and toe and waterside (WS) shoulder and toe. No permit has been identified since crossing was field discovered in 2012. FS Date: 10/11/2016 1:11:25 PM

Marker on LS shoulder and toe

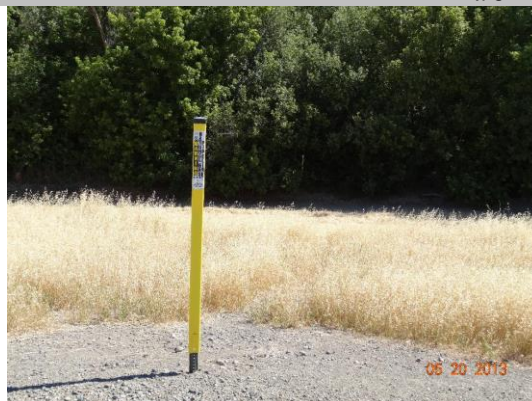
Photo 2 of 2 : UCIP_FA_2016_50252_64680.jpg

Item	DWR UCIP Field Study			39.024079 °	39.024079 °	
				-121.743420 °	-121.743420 °	
DWR ID						
Comment Code						
Inspector Comment						
FS_ID:50252						
DS_ID:23099						
EP_NO: N/A						
Repair Type: Non-Urgent						
Crossing Status: Found						
UCIP Comments: 10/11/2016 Crossing appears to be in good condition but there is no permit on file. Photos of the markers were uploaded on 5/20/2013.(DWR Sutter Yard - afreitag)5/3/2016 Need photos of markers on both WS and LS. 4/18/2016 Crossing appears to be in good condition. No noticeable issues to report.5/7/2015 Crossing is in good condition. No noticeable issues to report.11/13/2014 Same as last inspection.5/12/2014 Same as last inspection.10/30/2013 Same as last inspection.10/17/2012 Need to identify permit for crossing.						
FIELD_STRUCT_DESC: Unknown size natural gas pipeline through the levee at an unknown depth below the crown. Markers visible on the landside (LS) shoulder and toe and waterside (WS) shoulder and toe. No permit has been identified since crossing was field discovered in 2012.

Marker on WS shoulder
